Lester Guard Station, Ranger Station House  
(Guard Station Residence & Office, Bldg. No. 1036)  
Forest Service Road No. 45  
Lester  
King County  
Washington

HABS No. WA-172A

UNITED STATES DEPARTMENT OF THE INTERIOR  
NATIONAL PARK SERVICE  
HISTORIC AMERICAN BUILDINGS SURVEY  
ARCHITECTURAL DATA FORM

# GUARD STATION RESIDENCE AND OFFICE (BLDG# 030)

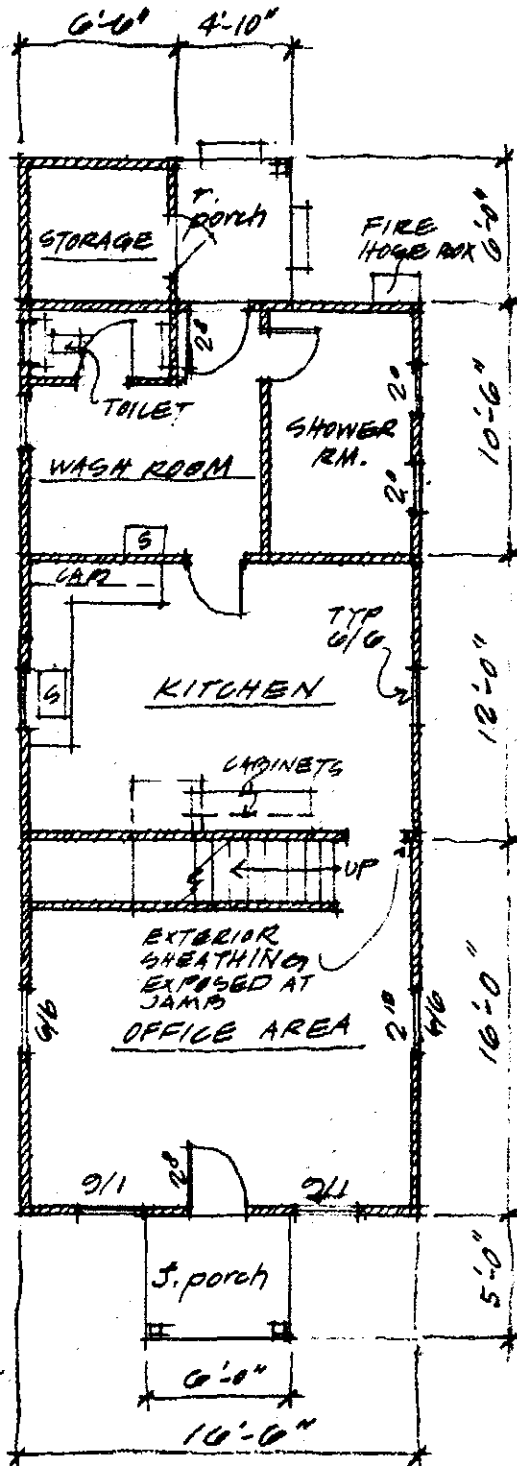
LOWER FLR

STYLE (IF APPROPRIATE) Vernacular		
MATERIAL OF CONSTRUCTION (INCLUDE STRUCTURAL SYSTEMS) Wood frame (2x4) with poured concrete perimeter foundation/post and pier foundation. Dropped wooden siding with corner boards. Cedar shakes over shingle roofing.		
SHAPE AND DIMENSIONS OF STRUCTURE (SKETCHED FLOOR PLANS ON SEPARATE PAGES ARE ACCEPTABLE) One and one-half story, rectangular (approx. 16'-6" x 38'-6") with semi-enclosed rear porch (6' x 6') and crawl space per sketch plan.		
EXTERIOR FEATURES OF NOTE The exterior is distinguished by a steeply pitched gable roof with exposed rafter ends and kneebraces at each gable end. Windows are wooden and vary in size and type and include, 6/6 double hung, 9/1 double hung, four light and six light hopper type with plain surrounds. A small gabled-roof open porch with kneebraces is located (cont		
INTERIOR FEATURES OF NOTE (DESCRIBE FLOOR PLANS, IF NOT SKETCHED) Office area, kitchen, wash room, toilet room and shower; first floor, sleeping areas; second floor per sketch plan. Beaded board (3/4" x 3-1/4" T&G) is located throughout first and second floor except office area. Fir flooring varies in width between first floor (2-1/4") and second floor (5" and 3-1/4"). (cont)
